1.0 INTRODUCTION

5.0 STRATEGIC MANAGEMENT PLAN

In order to develop management goals, objectives and strategies a clear vision is required to ensure that these goals, objectives and strategies are aiming to create the environment that is expected by the local community. The vision, mission and values of the original committee established to manage Lake Towerrinning are listed below.

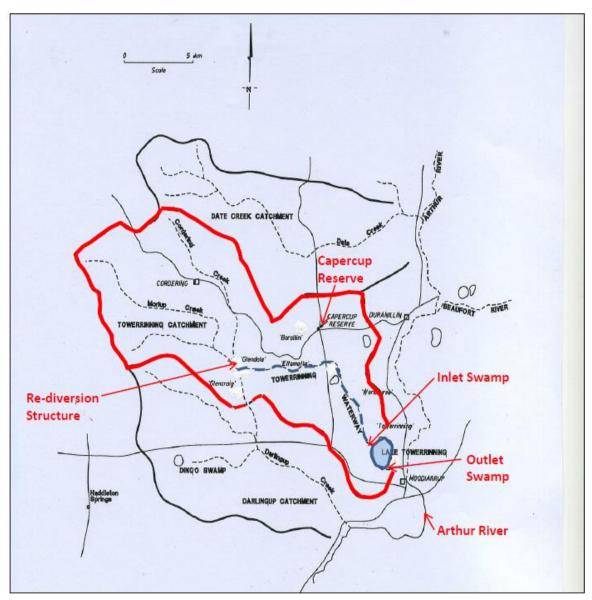
Figure 2: Lake Towerrinning catchment (Land Assessment Pty Ltd and Woodgis Environmental Consultants, 2012b).

The Lake Towerrinning catchment covers an area of approximately 15,700ha (Raper and van Wyk, 2009) which includes the Capercup Nature Reserve. The Lake sits at the bottom of the catchment and discharges into the Arthur River (Figure 2). Water coming into the Lake comes in through an inlet swamp on the north western side and is released to the Arthur River through an Outlet swamp located to the south of the main water body of the Lake.

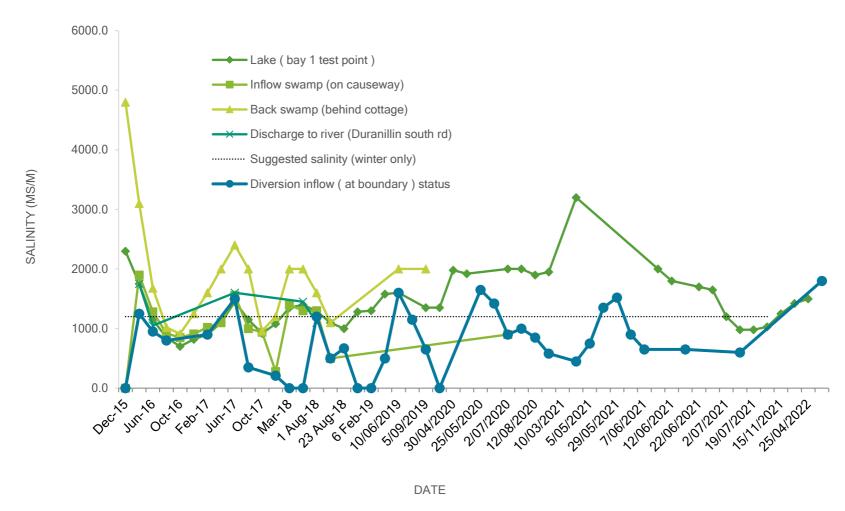
Figure 3: Salinity measures at Lake towerrinning from December 2015.

Since the construction of the re-diversion salinity levels within the lake have stabilised and range from <1,000-2,500 mS/m even in low rainfall years such as 2015 (Figure 3, data collected by Lakeside Camping). Water salinity in the outlet swamps is higher with average salinity in the outlet swamp approaching sea water (JDA Consultant Hydrologists, 2012).

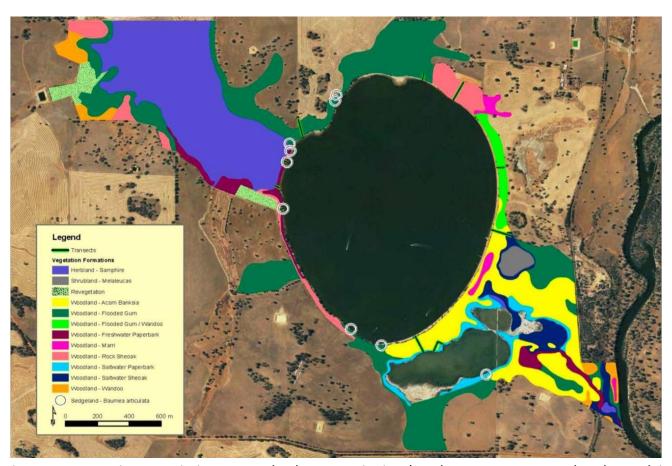
Figure 4: Vegetation associations around Lake Towerrinning (Land Assessment Pty Ltd and Woodgis Environmental Consultants, 2012a)

These vegetation associations consist of:

- woodlands around the main water body of the Lake of either flooded gums (E. rudis), rock sheoak (Allocasuarina huegeliana), mixed flooded gum/wandoo (E. wandoo), acorn banksia (B. prionotes), or freshwater paper bark (Melaleuca rhaphiophylla) with two small pockets of marri (C. calophylla) woodland.
- woodlands around the back swamps of saltwater paperbark (*M. cuticularis*), saltwater sheoak (*Casuarina obesa*), freshwater paperbark (*M. rhaphiophylla*), acron banksia (*B. prionotes*), or flood gum (*E. rudis*); and
- freshwater paper bark (*M. rhaphiophylla*), rock sheoak (*A. huegeliana*), samphires (*Tecticornia* spp.), flooded gum (*E. rudis*), wandoo (*E. wandoo*) around the rediversion drain entering the Lake.

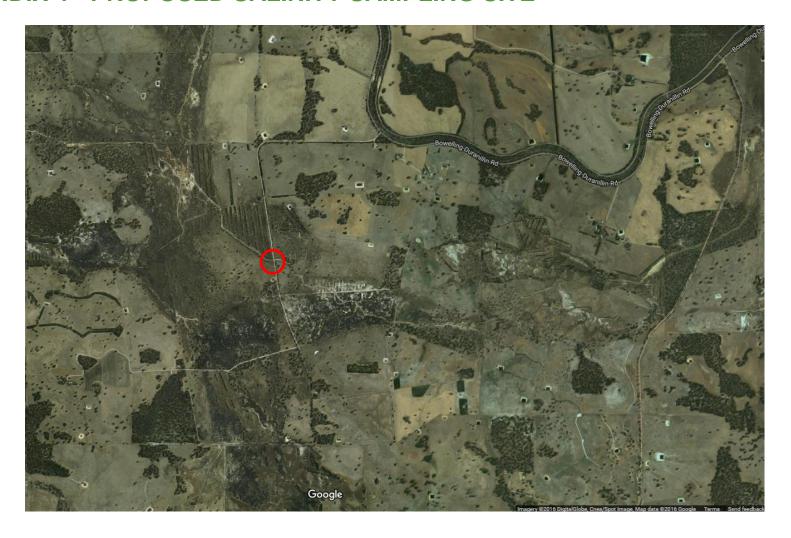
APPENDIX 4 - PROPOSED SALINITY SAMPLING SITE

OBJECTIVE	STRATEGY	HOW	EN W	VHO
Maintain water levels cont'd	Investigate means to improve water flow into the Lake.	culvert in the re-diversion dam and upgrading the W-drain to increase water flow to the lake as per recommendations from the JDA Living Lakes Project. Investigate the potential to drain water from Capercup Nature Reserve into the W-drain and into the lake. This will assist with salinity in the Reserve and also improve water flow into the lake. Liaise with the disbanded Lake Towerrinning Catchment group regarding remaining funds and the potential for these funds to be invested into improving the rediversion structure.	hat La provements can of made during low La fall seasons	hire/ andcare fficer/ andowners
Maintain salinity levels in the Lake at <1200ms/m during winter months (Raper and van Wyk,	Monitor quality of water passing through the re-diversion system during the summer months.	Monitor the salinity annually at the road crossing/culvert on Scott Road (see Appendix 4).	ce during winter Sh	hire
